At Load Power Factor Correction

A Pilot Project to determine the feasibility and economics of small scale "At Load" Power Factor Correction

Richard Ellenbogen, MEE

NYSERDA Project Name: Local Distribution Power Factor Correction (At the Load)

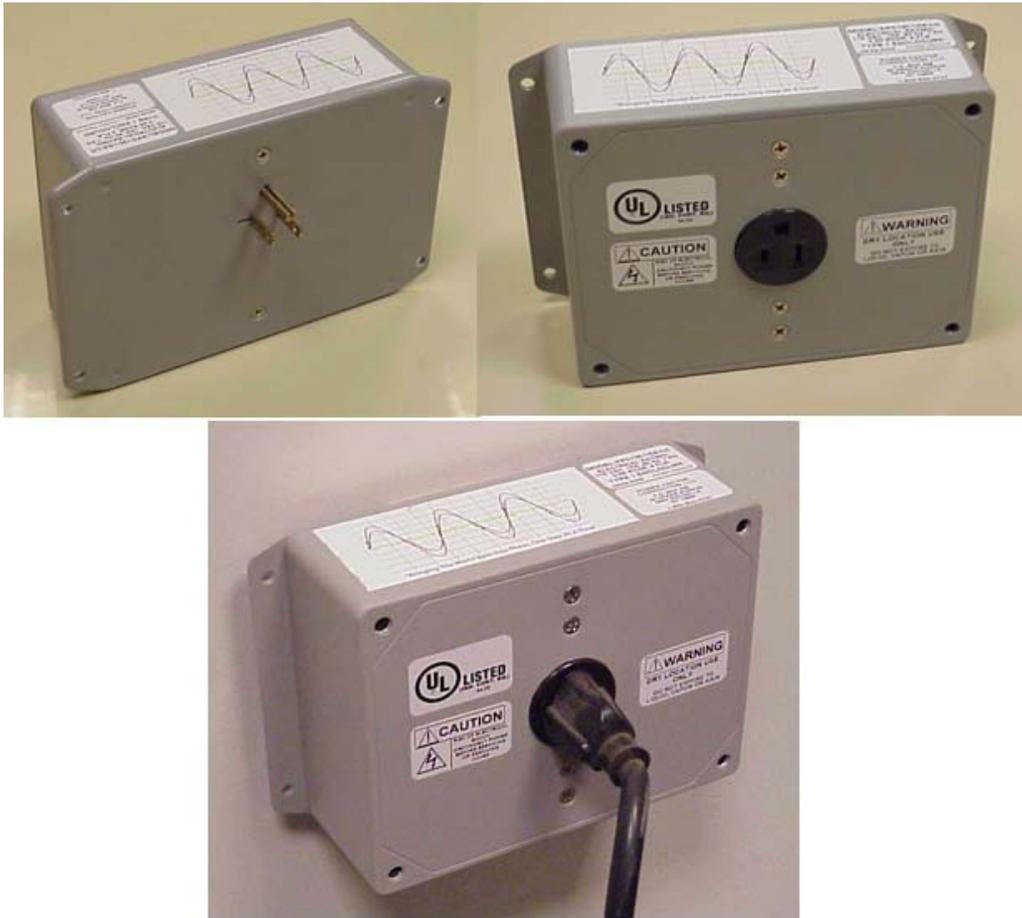
Figure 11: The PLIP[®] Plug In Power factor correction. Power Factor Correction Installation costs are greatly reduced. An unskilled person can install these.

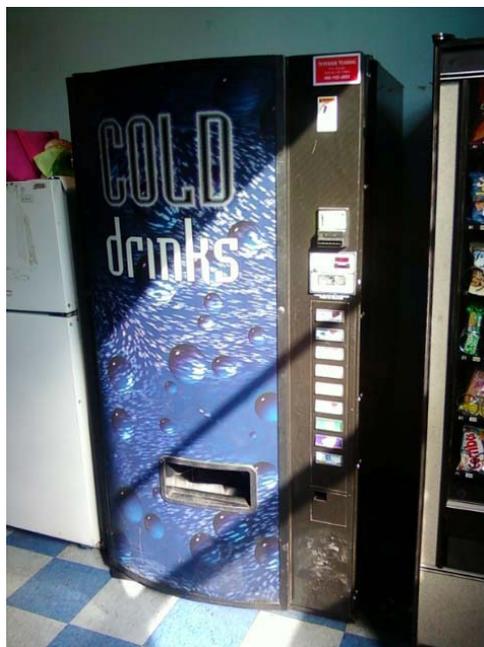
Figure 12: A Dixie-Narco Vending Machine, The waveform for this machine appears in Figure 13.

Figures 13, 14, and 15 show the before and after graphs from three vending machines that are representative of the various machines that were tested. On all of the machines, it can be seen that at least a 2 ampere reduction was achieved through the implementation of power factor correction. On average, a 2.2 ampere reduction and a 0.26 KVA reduction was achieved per machine. Extrapolated over 180,000 machines in New York State, that corresponds to a 46,800 KVA reduction in coincident peak demand and a 40,600 KVA reduction in continuous load on the distribution system based on an 87% duty cycle for the equipment. 3.6% of energy is lost annually as distribution losses and 88% of that is copper loss, resulting in 3.2% of all losses being distribution copper losses. Applying that to the 40,600 KVA reduction in average demand results in a 1300 KW average reduction in required generation and a 1500 KW reduction in peak generation related to the reduced currents resulting from power factor correction. Using the figure of a 1300 KW average power reduction yields a net annual savings of 11,388,000 KWH annually in reduced losses on the distribution system. However, in addition to savings on the utility's distribution system there will also be significant savings on the customer's side of the meter within the customer premises. This will occur because of reduced heating within the premise's wiring that is manifested as KWH on the utility bill. Measurements that we have taken at industrial locations indicated that raising the power factor from .7 to .96 can reduce KWH loss by as much as 5% to 7% within customer premises. A lower initial power factor will yield more dramatic KW savings resulting from power factor correction. The power factor of refrigerated vending machines is sufficiently bad that large KW reductions can be achieved through correction.

Figure 13: Before and after waveforms from a Dixie-Narco vending machine. A 2.3 ampere (31%) current reduction was achieved through the use of power factor correction.

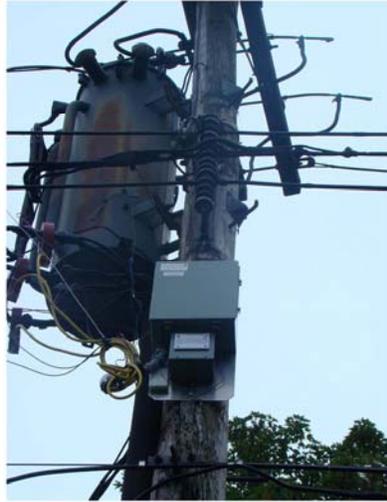
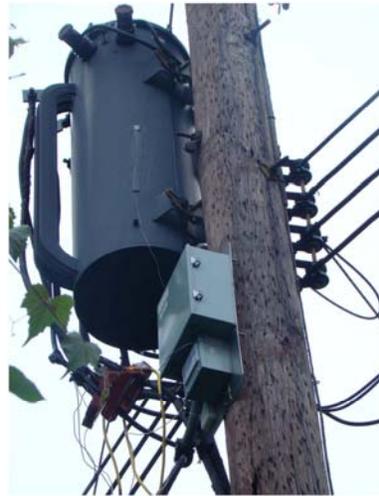
Figure 16: Pole Monitors at Hilltop Terrace. Monitor 10 services one building at Hilltop Terrace and a second building in a different complex. Monitor 11 services five buildings at Hilltop Terrace. The transformer at Monitor 10 is a 75 KVA, 3 phase transformer. The transformer at Monitor 11 is a 150 KVA, 3 phase transformer. Both transformers date to the construction of the complex in 1965.

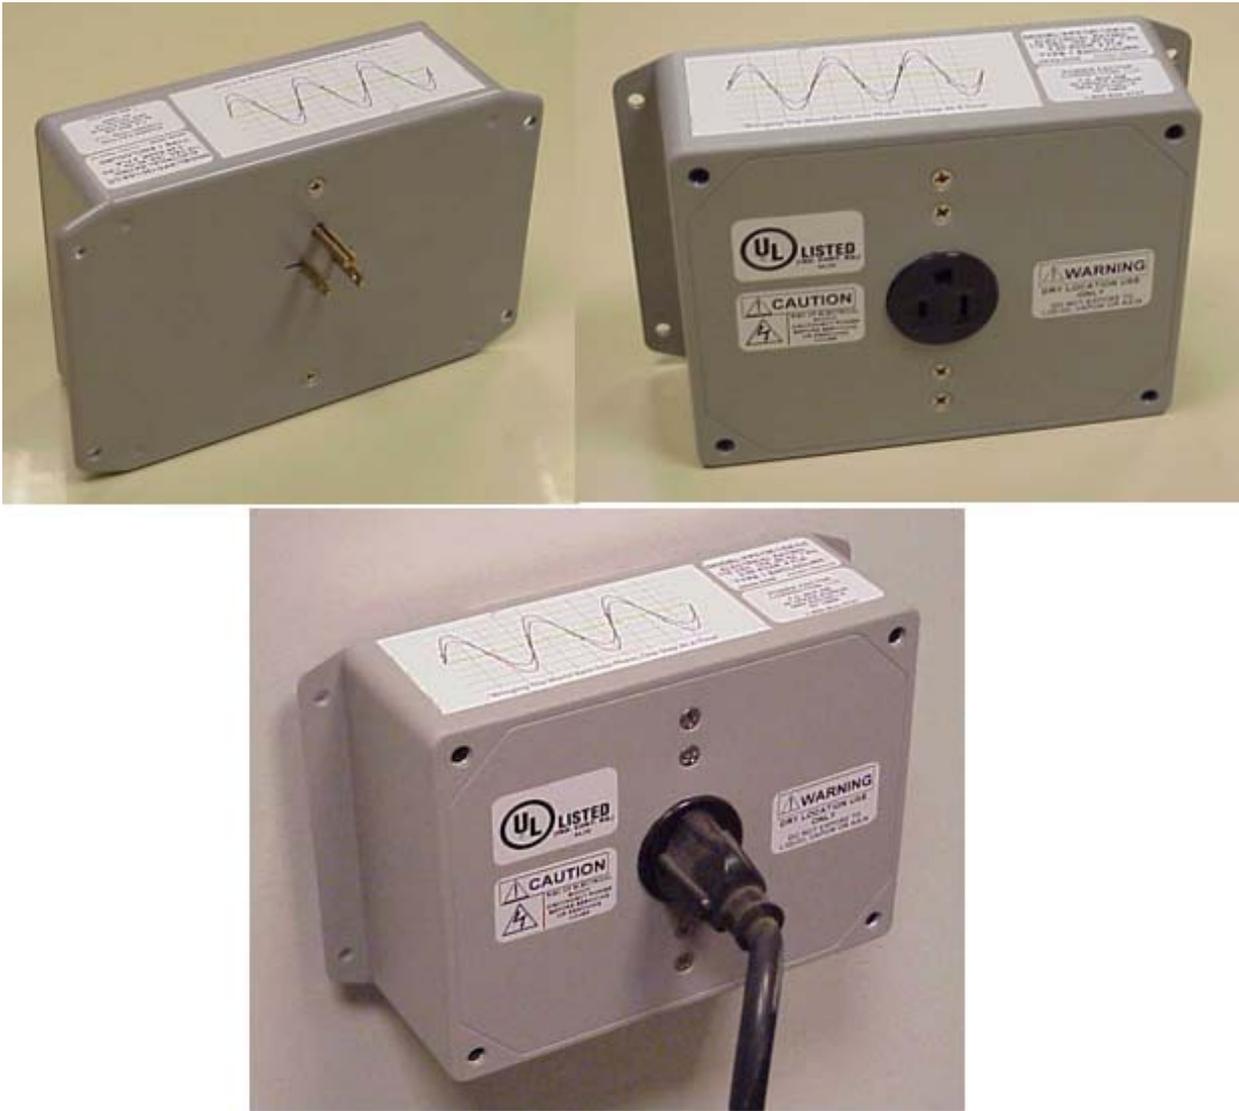
Figure 18: The PLIP[®] Plug In Power factor correction. Power Factor Installation costs are greatly reduced. An unskilled person can install these. After three days of taking measurements, we knew on sight which pieces of equipment needed correction.

- 7 Device Design :** While devices for power factor correction are readily available for large facilities, that is not the case for the smaller scale application that we are considering here. Labor and other installation costs have to be kept to a minimum in order to make this process viable. In the past, one of the reasons that small scale power factor correction has not been applied is installation cost. The bulk of that cost is in labor. After applying for the grant and prior to being approved for the grant, we designed and fabricated devices that could be installed by a non-technical person. No electrician is needed. A patent was filed on these devices, called PLIP's[®], in November, 2008. PLIP[®] is an acronym for “Plug In Power Factor Correction”. Figure 18 is a photo of a PLIP[®].

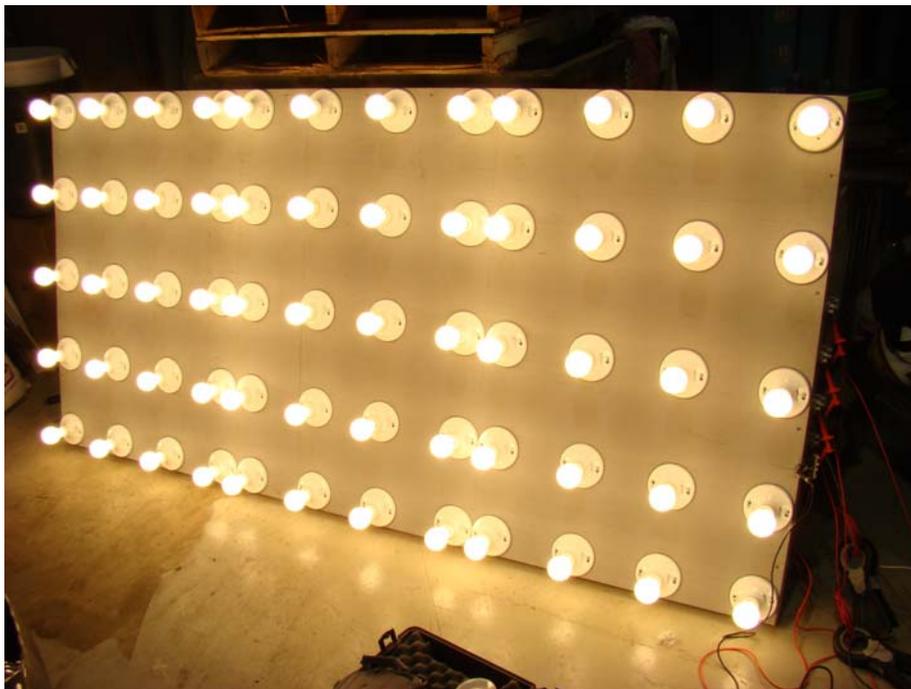
To test this hypothesis, we created an experiment. To implement the experiment, we needed a harmonic source. From our earlier experiments with Compact Fluorescent Light Bulbs (CFL’s), we knew that they would generate significant levels of harmonics. We used twenty 13 watt CFL’s on a single phase circuit. The test apparatus is shown in Figure 31. The test apparatus will hold 60 bulbs, twenty per phase, across three phases. We used a single phase of the board for our test.

Figure 31 – Light Board used to generate harmonics
